CASE STUDY

RESTORING CORROSION MONITORING ACCESS THROUGH SEIZED PLUG REMOVAL

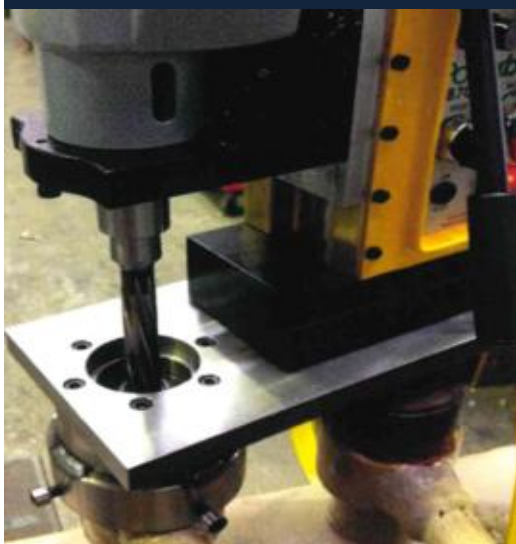
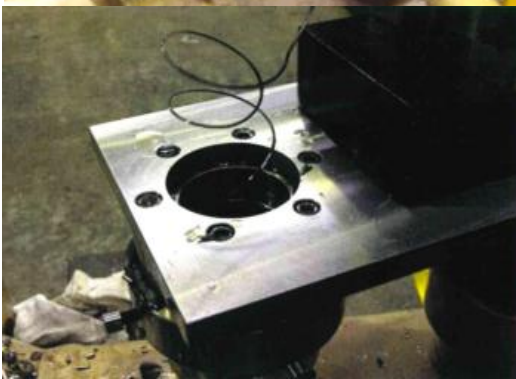
MOSS was engaged to remove seized plugs from corrosion monitoring access fittings, where loss of maintenance access was impacting monitoring capability and posing integrity risks.

Conventional solutions required full component replacement - driving cost, downtime, and disruption. The scope was further complicated by varied plug configurations, restricted access, and the need to preserve fitting and pipework integrity.

MOSS mobilised the precision machining equipment designed to operate within restricted access environments. Specially designed mounting arrangements ensured secure alignment and stability during machining, allowing accurate removal of seized plugs without damaging the parent fitting.

The machining process and tooling selection were carefully controlled to eliminate risk to the fitting body, maintaining full structural and pressure integrity of the system.
